## Evaluation of a Retrofit OH-58 Pilot's Seat to Prevent Back Injury

Joseph L. Haley, Jr.  
COBRO Corporation

December 1994

United States Army Aeromedical Research Laboratory  
Fort Rucker, Alabama 36362-0577

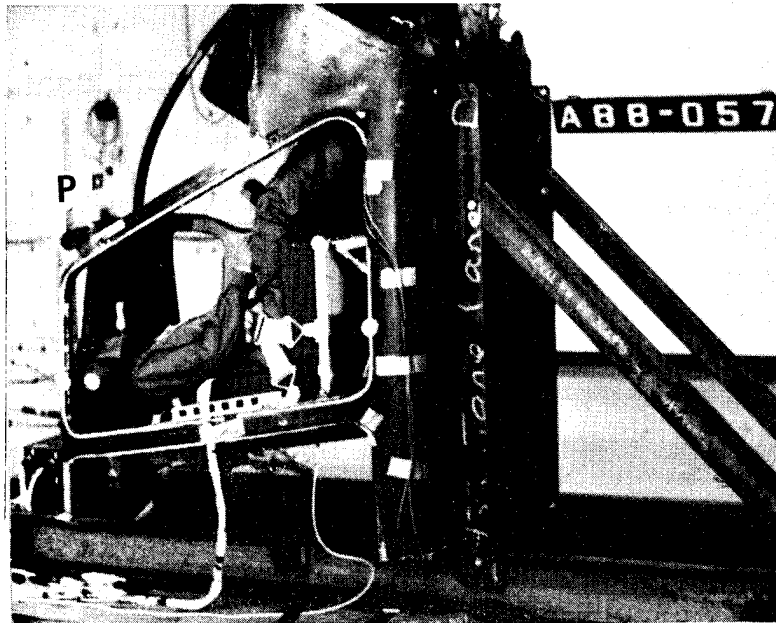
Pre- and posttest profile photographs are at Figures 13 and 14. All transducer traces for the test are at Figures A-1 through A-3. The right seat 50th percentile dummy stroked 4.75 in at the BRP, a point on the surface of the seat cushion located 5.75 inches forward of the seat reference point (SRP) with the cushion deflected under a 1 G load (see Figure 5). As shown in Table 3, the stroke of the seat was determined by BHT, based on the deformation of the wire bender which was replaced after each test; the seat BRP displacement also was measured directly by a CAMI rotary potentiometer with a quoted "5 G extraction limit." In this one case, the two methods agreed within experimental accuracy (4.75 and 4.8 inches), but the potentiometers showed excessive deflection in the other five readings shown in Table 3. The potentiometer output traces are shown in Figures A2, A5, and A9, and the probable potentiometer "overrun" points are shown on these traces. Since the seat pans were accelerated downward at 1000 G/sec up to a sustained 20 G level, it is clear that the "5 G extension" limit was exceeded, but the error appears to be related to rotational inertia of the device which permitted it to reel out excessive cable; the beginning of seat pan stroke agrees with film analysis and with dummy transducers.

Figure 13. Test setup for pure vertical crash vector--test 88057 (the aluminum channel and bracket used later for pilot display unit tests shown with "P").

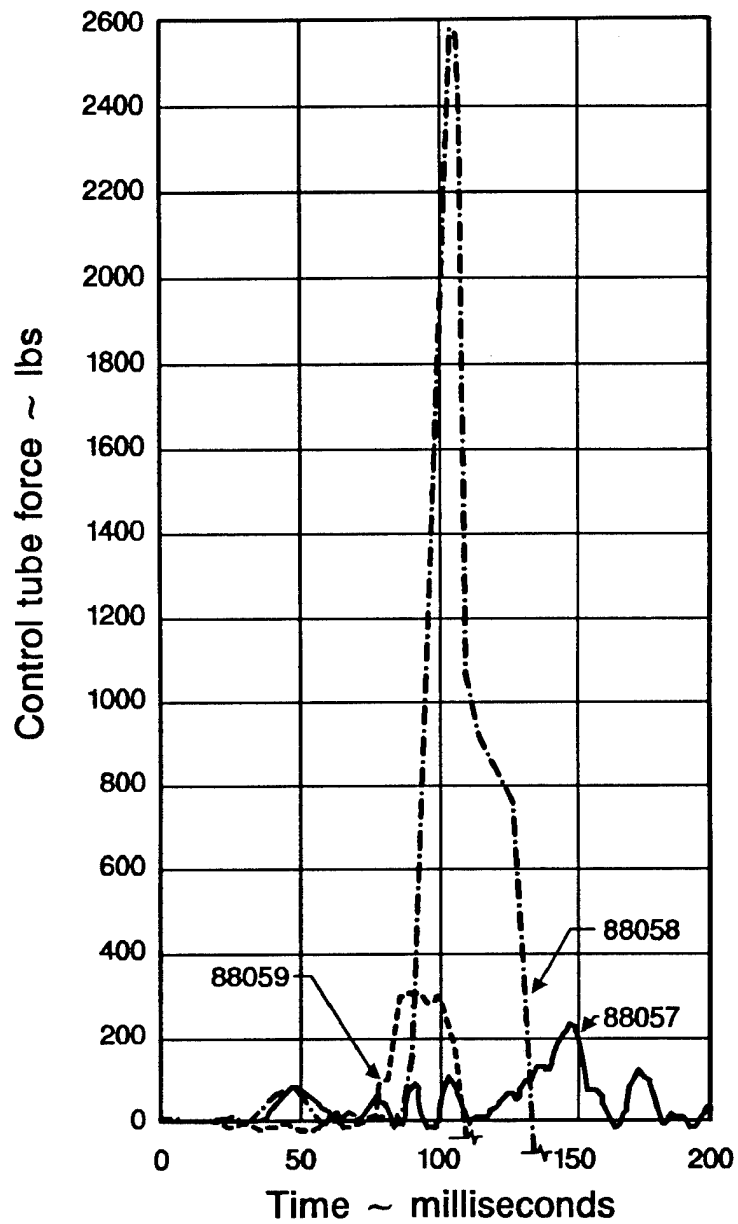
The impact force caused by seat armor plate contact with the yoke was measured indirectly by placing a load cell at the top of the control tube as shown in Figure 15. The measured control tube forces in all three seat tests are illustrated in Figure 15. It is pertinent to observe in test 88057 that the relatively mild control force contact occurred at 90 ms as revealed by reference to Figure A-2 which shows the left seat reached 5.4-inch displacement (the left seat BRP stroke available up to yoke contact) at 90 ms time. Further evidence is gleaned from the z-axis acceleration of the left seat dummy's pelvis in Figure A-3 suddenly increasing from 15 G to 40 G between 91 and 94 ms; the left seat pan acceleration (Figure A-1) also shows a sudden increase from 10 G to 20 G in the same time span. The deceleration of the left seat pan reaches zero at 112 ms but the left pelvis deceleration is sustained through 140 ms and the left seat bracing tube sustains a load of 490 lb at 150 ms (Figure 17). This apparent anomaly probably is explained by the considerable stored energy in the seat cushion and dummy buttocks and spinal column causing compressive forces to remain in the seat cushion and dummy after seat pan downward motion ceases.

Reference to Figure 15 shows the control tube force increased about 1 ms sooner than in test 88057, probably due to the lesser stroke available before yoke contact as shown in Figure A5 in the 82-85 ms time frame. Figure A5 also shows the right seat dummy's lumbar load cell overshoot from 1100 to 2125 lb between 85 and 95 ms, and Figure A4 shows both vertical seat pan transducers producing values of 30 and 45  $G$  at about 92 ms. The control tube force peaked at 2590 lb at 104 ms, and then returned to zero at 134 ms, just about the time the left seat lumbar  $G$  value reduced to zero.

Figure 15. Load cell force measured due to impact of the pivoting seat pan with the under-seat control yoke (see Figures 4 and 23).

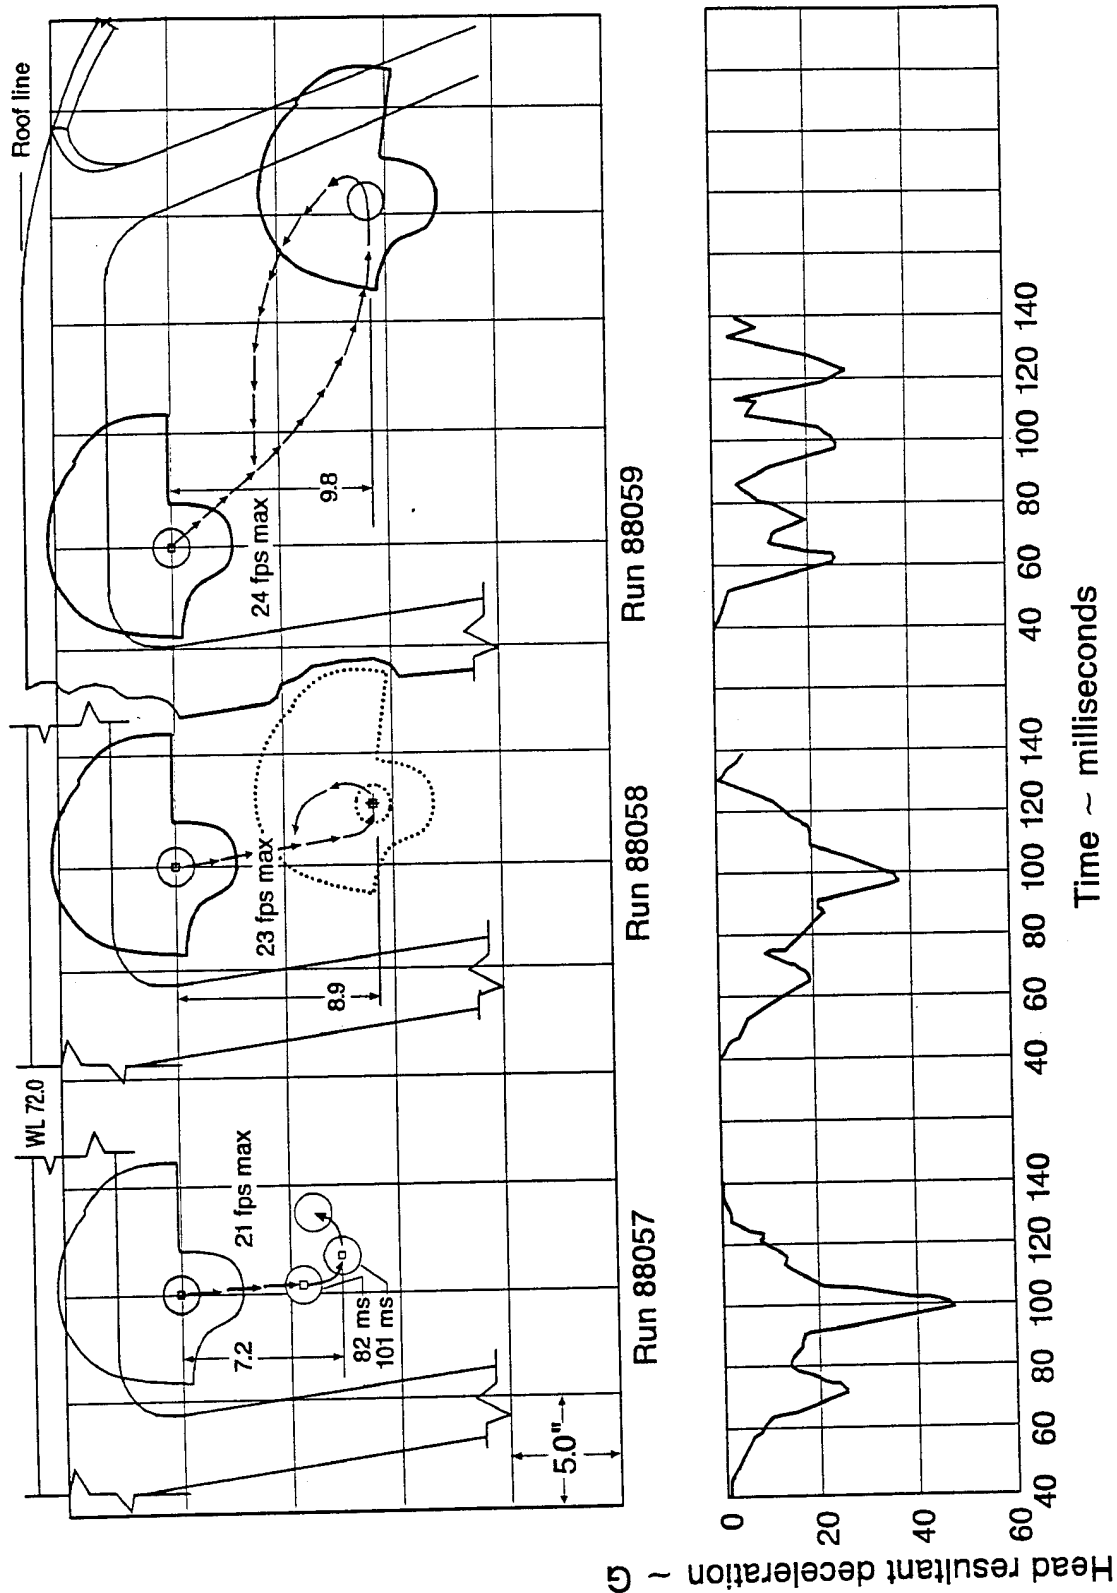
Note in Figure 16, which shows the right dummy's helmeted head movement, that the helmet displaced downward 7.2 inches, fully 2.4 inches more than the 4.8-inch movement of the dummy BRP; this difference is estimated as follows:

Again, film analysis of this test showed more downward movement of the helmeted head in Figure 17 than shown in Table 3 ( $8.90'' - 4.82'' = 4.08''$ ). Although load-compression data for the seated 50th percentile dummy was not available for analysis, it is assumed the 4.08 inch compression occurred as was estimated in test 88057, except that incremental values were about 60 percent greater. The significance of this considerable compression in the dummy and seat cushion is the stored energy which tends to propel the dummy upward after the impact. The rebound webbing, shown in Figures 4 and 5, permitted the armor plate to rebound about 40 percent of the stroke as noted by Fox in BHT Report no. 699-099-286, pages 4-14. Fox also noted the spring-loaded cam on the webbing slide needed more pressure against the webbing, and the 2-foot long yoke beam, deflecting 1.4-1.6 inch, served as a flat spring being struck near its center; the writers concur with the BHT comments.

Figure 16. Measured helmet movement of right side dummy from film analysis and head deceleration (runs 88057, 88058, and 88059).

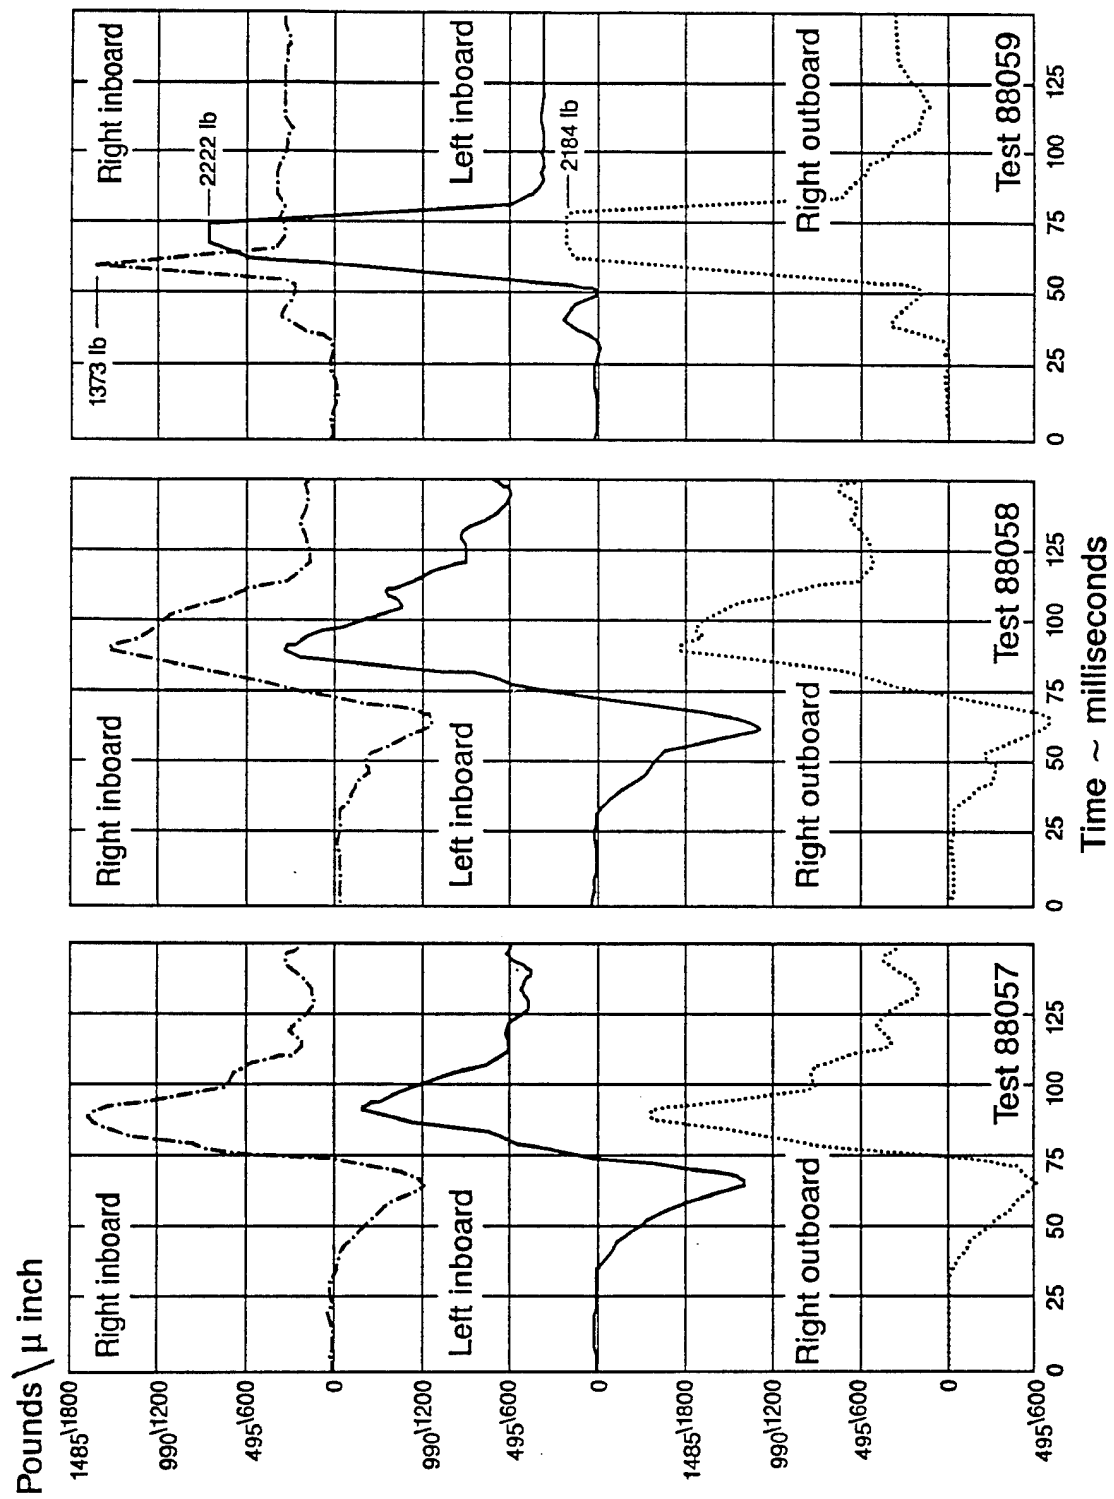
This dynamic test definitely revealed the need to use the braces for the front bulkhead support. The strain in these braces was converted to load as follows (refer to Figure 8 for strain gage locations): The axial unit strain  $e$ , in the absence of torsional strain (bending strains were cancelled by symmetric gage placement), is equal to the stress in the tube divided by the tube modulus of elasticity, i.e.,  $e = \frac{S}{E}$ ,

Thus, the above load is equal to each 600-microinch increment of strain in Figure 17 where all three bracing tube traces are shown on a common time base and all three tests are shown together. Observe the similarity of the load versus time variation of the three brace tubes; at 32 to 35 ms, all show a compressive load increasing to 500 lb each on the right seat, and 840 lb for the inboard brace of the left seat. The peak compressive load occurs exactly at 67 ms, then reduces to zero at exactly 74 ms, and continues to increase to a peak tensile load at 90 ms on the right seat with medium-size dummy and at 92 ms for the left large dummy. The 2-ms lag of the left seat also may be observed in the seat pan acceleration (Figure A1) in which the peak negative  $G$  of 20 and 22  $G$  (left and right) begin to decrease at 103 and 101 ms. The right seat, right tube sustained 1735 lb compared to 1368 lb in the left; this difference would be expected since the center line of the right seat lap belt anchors is located about 0.7-inch outboard of the brace tube center line at BL 13.75R. The load in all three tubes reduces from their peak values to 500 lb or less at 117 ms; from 117 to 150 ms, the left seat sustains the load longer than does the right seat. This same extended time rebound force also is apparent in the left seat tube in the next two tests (88058 and 88059).

Figure 17. Measured axial strain in aluminum bracing tubes and calculated loads.

Since the anchorages did fail after sustaining this force for about 10 ms (Figure 17), we believe only a small strength increase would sustain the test loads. It is suggested the horizontal shear be carried through the honeycomb "bathtub" at the outboard edges of each seat and at the center console web. The cost and weight of a web structure should be lower than the separate bracing tubes.

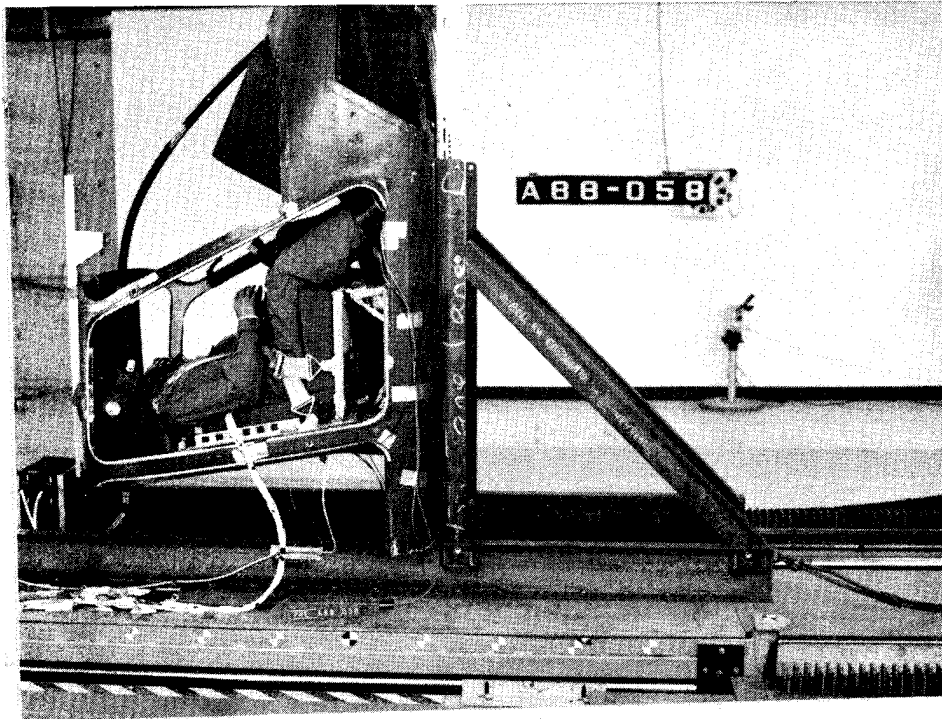
The only difference in this test and test 88057 was the increased velocity to 29.6 fps from 26.5, and the collective control being placed in the "full down" position yielding about 1 inch less available stroke before under floor yoke contact. Pre- and posttest photographs from the right side are at Figures 18 and 19. A posttest view from the left side is at Figure 20. All transducer traces for the test are at Figures A4 through A7.

**Figure 18.** Pretest view of test 88058 (note added beams below nose to stiffen the fuselage).

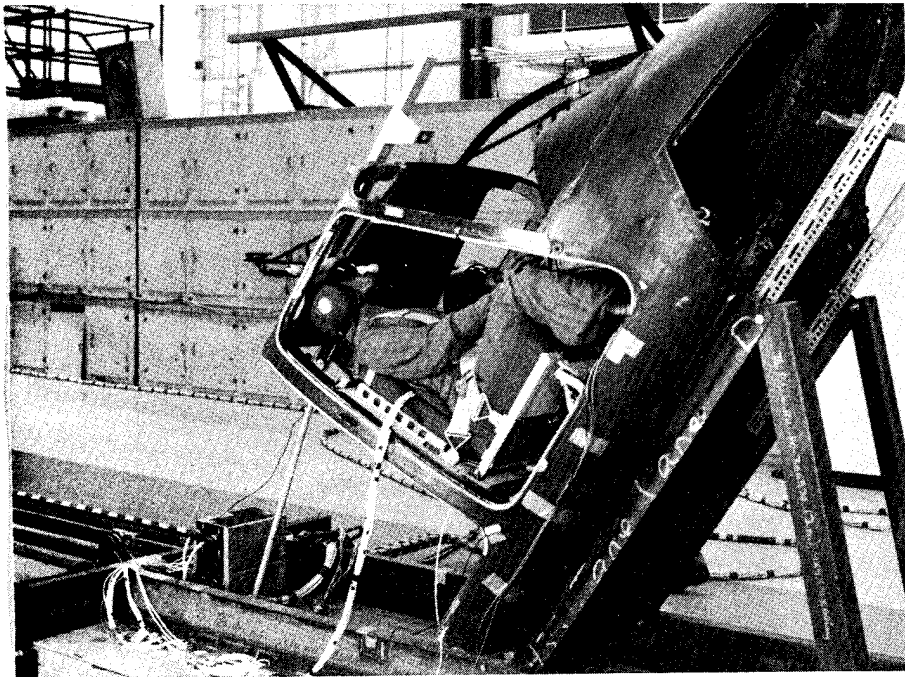
Pre- and postimpact photographs are at Figures 21 and 22. The steel tube running from the sled to the fuselage ceiling is shown clearly in Figure 22. This tube was intended to prevent horizontal shear deformation in the fuselage due to the horizontal crash loads.

Figure 21. Pretest view of test 88059 (note the fuselage is pitched 56 degrees from vertical in lieu of 90 degrees).

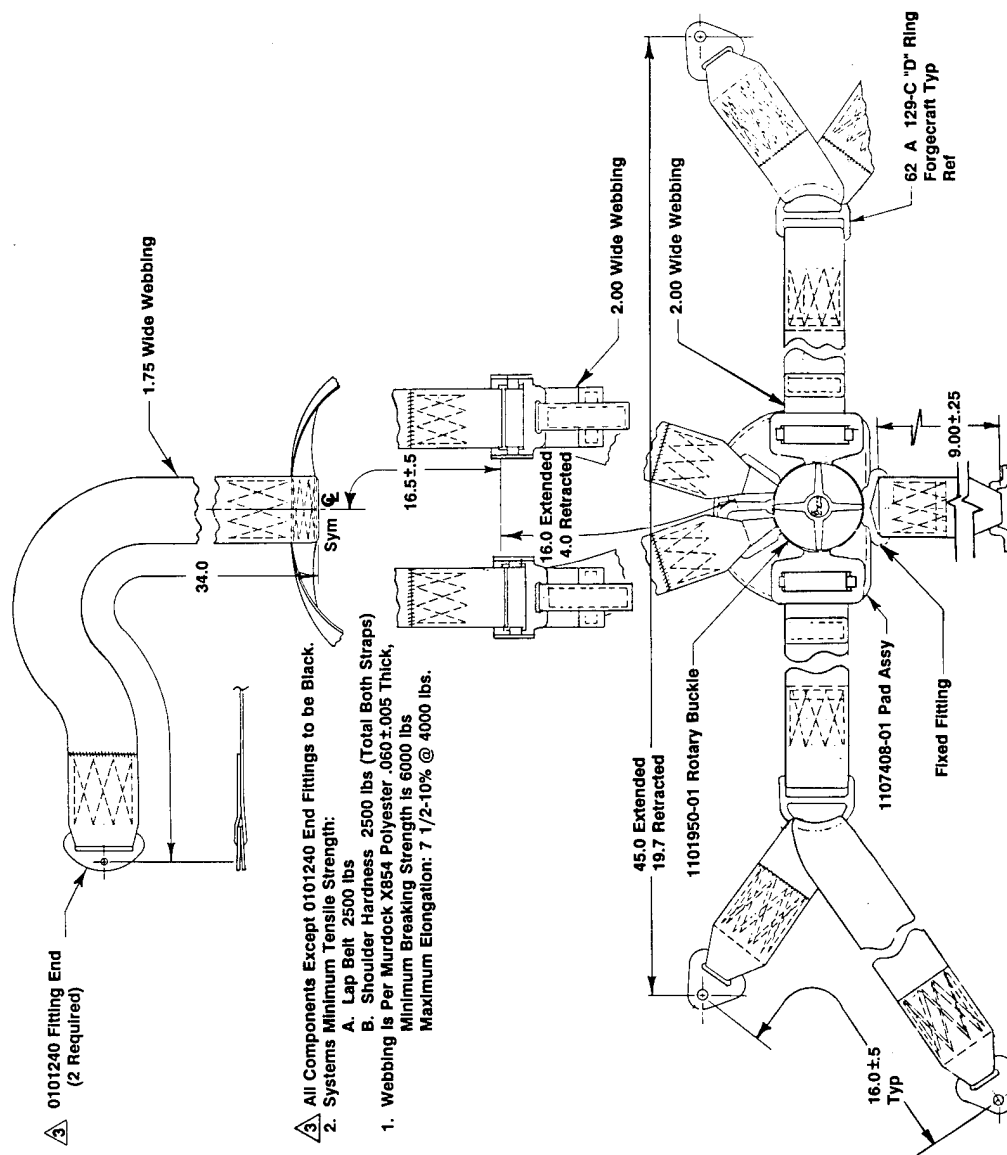
Figure 31. Five-point restraint harness proposal (Pacific Scientific Company, or equivalent).

d. A lightweight (2.8 lb), 5-point harness, equivalent to the one shown in Figure 31 be provided to replace the current 4.6-lb harness.
